**DRAFT REPORT
ROUND 7 DAM ASSESSMENT
ASSOCIATED ELECTRIC COOPERATIVE, INC.
NEW MADRID POWER PLANT
ASH POND 1 & 2 AND SLAG POND 1 & 2 IMPOUNDMENTS
NEW MADRID COUNTY, MISSOURI**

January 14, 2011

Re: Round 7 Dam Assessment - Draft Report
EPA Contract No. EP10W001313
Associated Electric Cooperative, Inc. New Madrid Power Plant
Ash Pond 1 and 2 Impoundments and Slag Pond 1 and 2 Impoundments
New Madrid County, Missouri

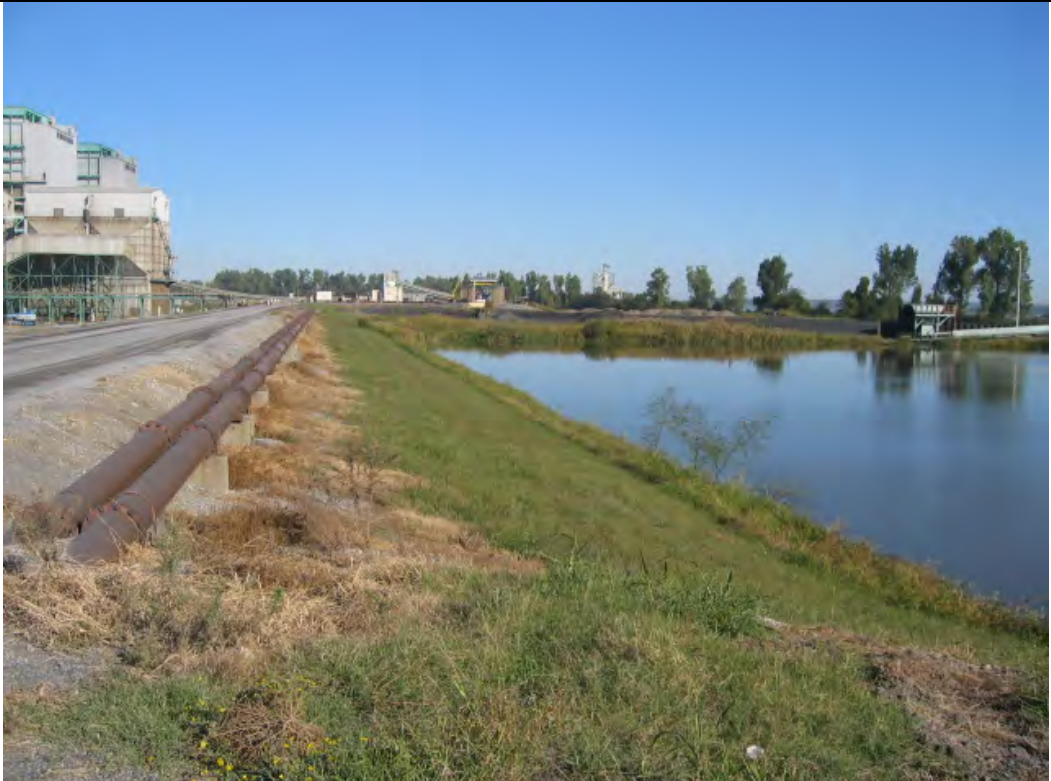
Client Name: U.S. EPA		Site Location: New Madrid Generating Facility Marston, Missouri	Project No. 01.0170142.20
Photo No. 1	Date: 10/6/10

Direction Photo Taken: Northwest			
Description: Upstream slope of the Slag Pond 2 Impoundment (SP2).

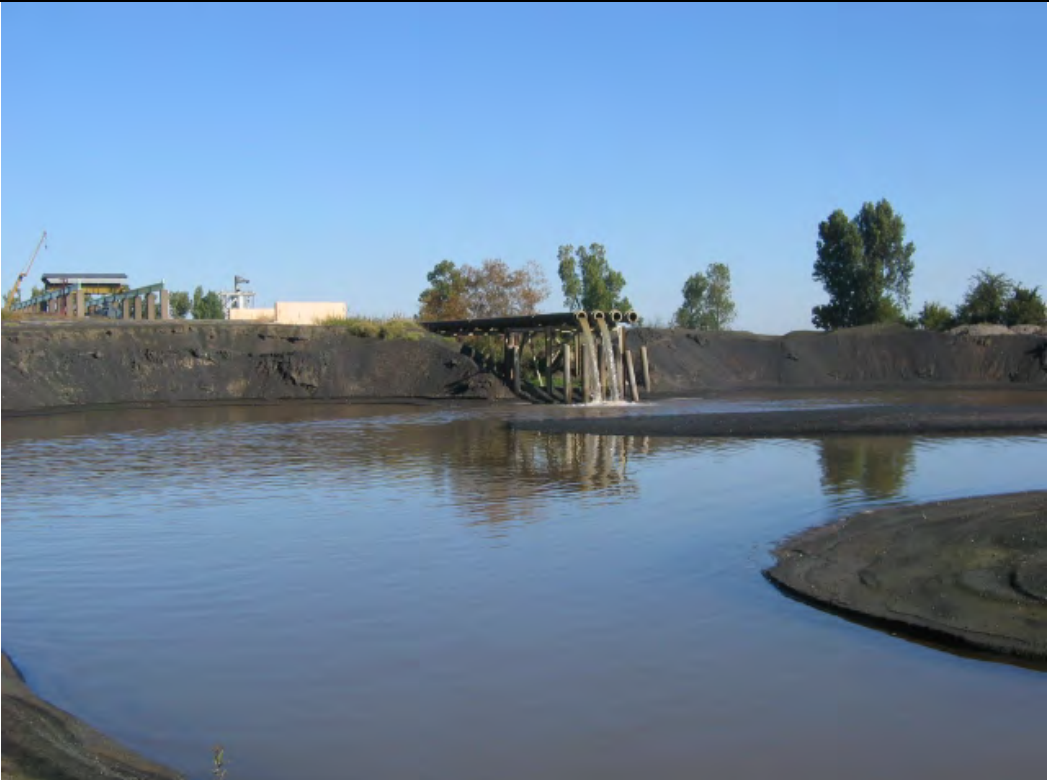
Client Name: U.S. EPA		Site Location: New Madrid Generating Facility Marston, Missouri	Project No. 01.0170142.20
Photo No. 3	Date: 10/6/10

Direction Photo Taken: Northeast			
Description: Upstream slope and discharge pipelines of the SP2.

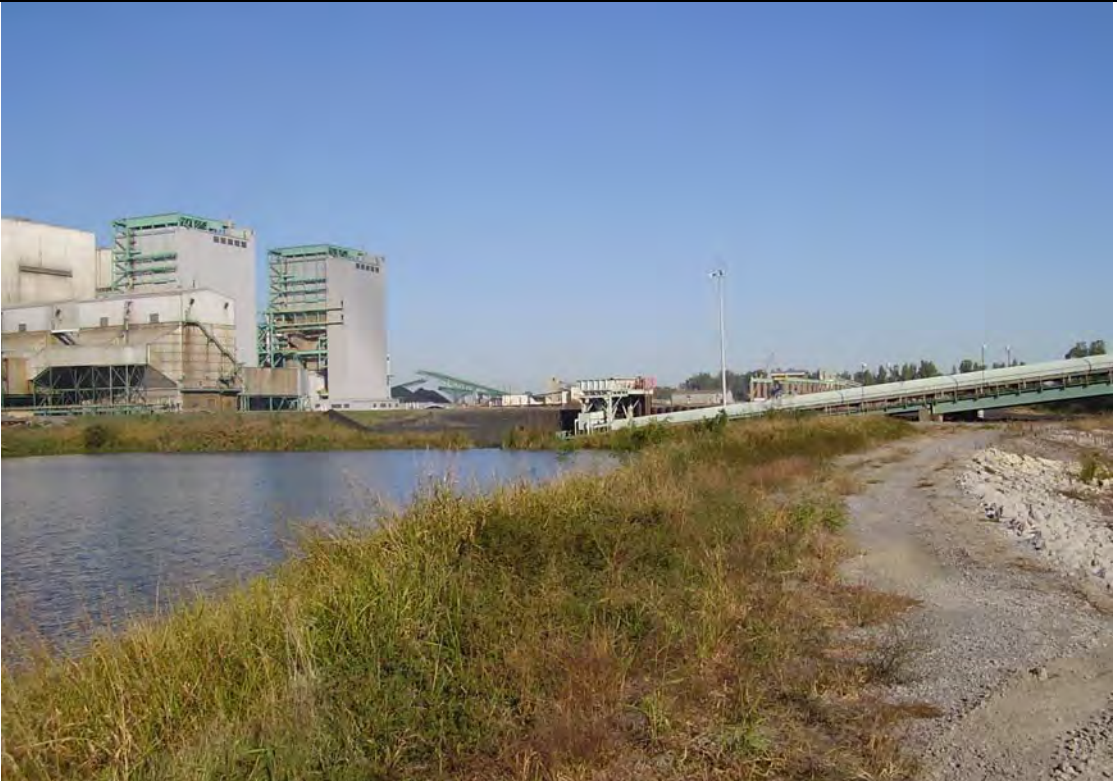
Client Name: U.S. EPA		Site Location: New Madrid Generating Facility Marston, Missouri	Project No. 01.0170142.20
Photo No. 5	Date: 10/6/10

Direction Photo Taken: Northwest			
Description: Upstream slope of the SP2.

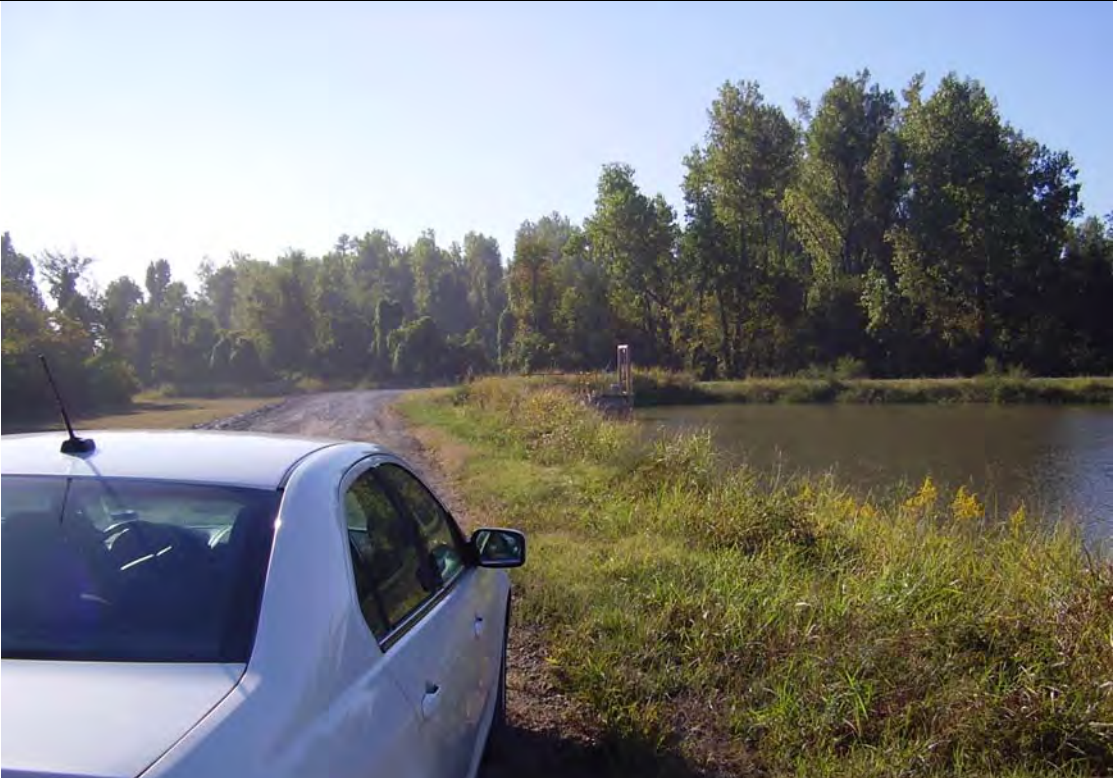
Photo No. 6	Date: 10/6/10

Direction Photo Taken: Southeast		
Description: Upstream slope of the SP2.

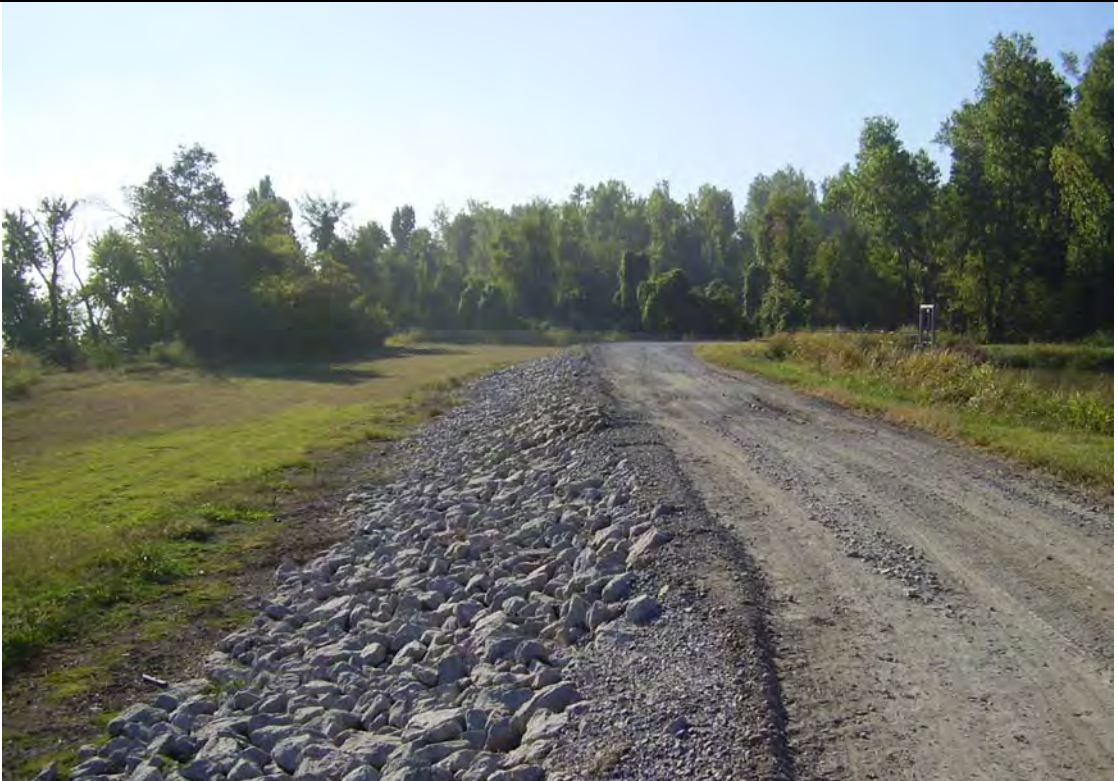
Client Name: U.S. EPA		Site Location: New Madrid Generating Facility Marston, Missouri	Project No. 01.0170142.20
Photo No. 7	Date: 10/6/10

Direction Photo Taken: Southeast			
Description: Crest and downstream slope of the SP2.

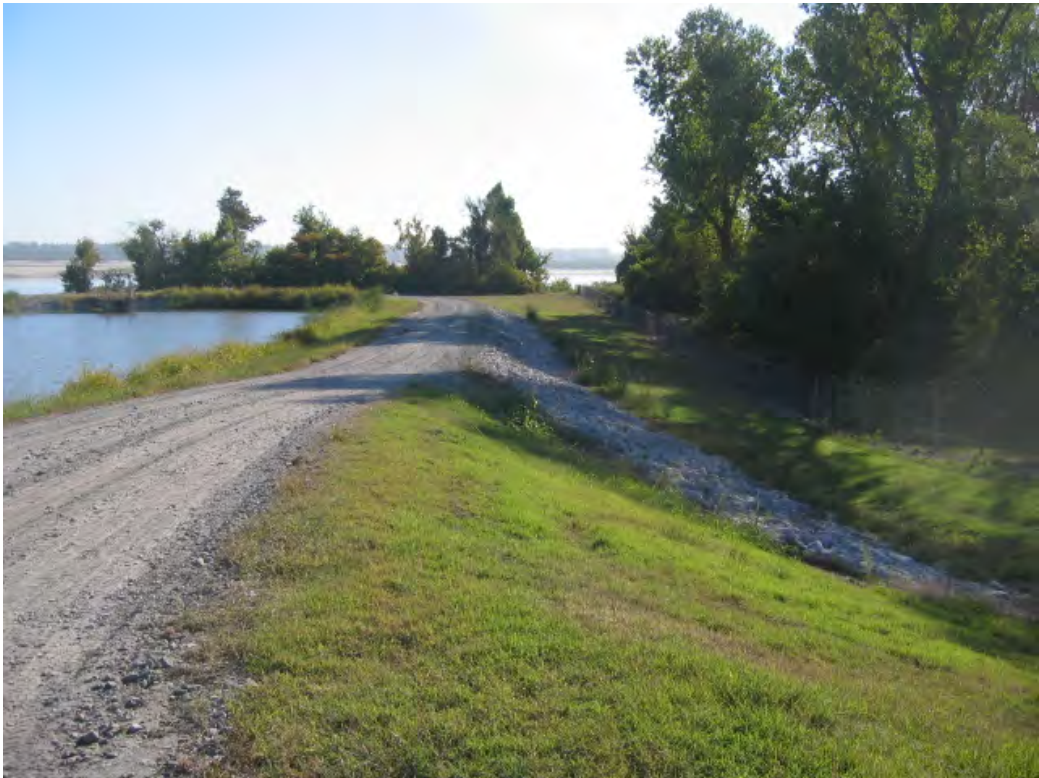
Client Name: U.S. EPA		Site Location: New Madrid Generating Facility Marston, Missouri	Project No. 01.0170142.20
Photo No. 9	Date: 10/6/10

Direction Photo Taken: East			
Description: Crest of the SP2.

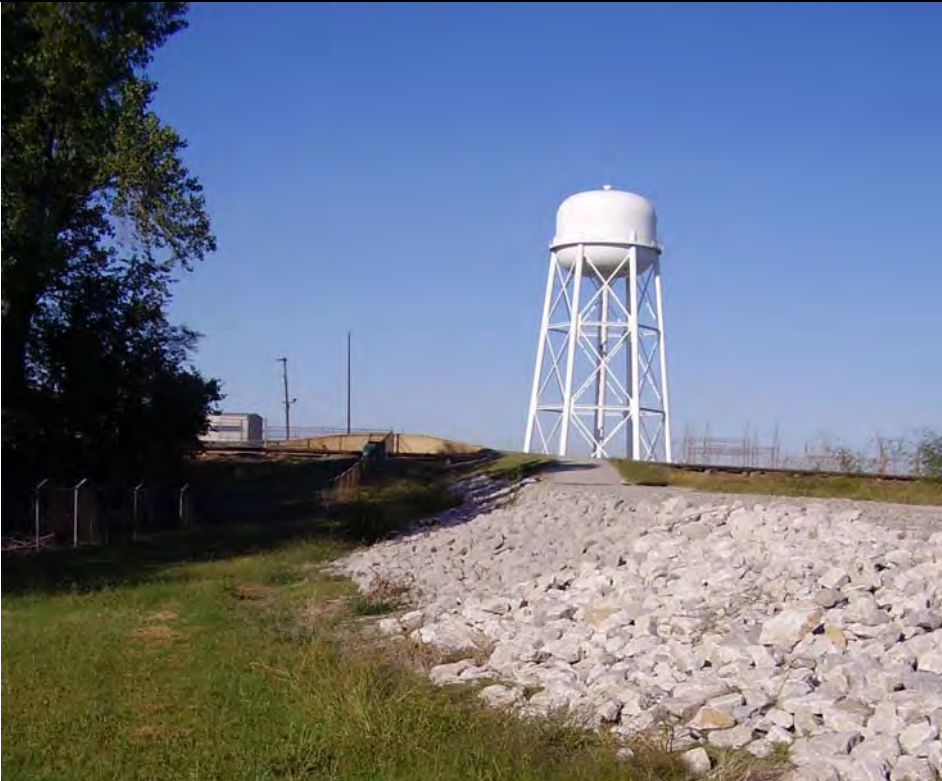
Client Name: U.S. EPA		Site Location: New Madrid Generating Facility Marston, Missouri	Project No. 01.0170142.20
Photo No. 13	Date: 10/6/10

Direction Photo Taken: West			
Description: Downstream slope of the SP2.

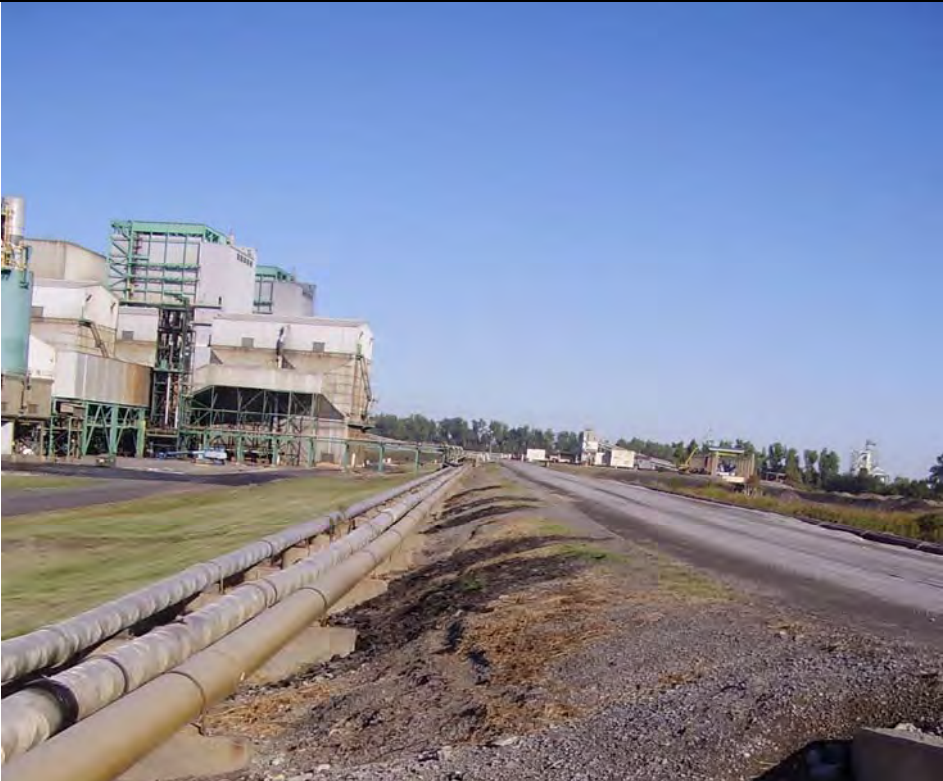
Client Name: U.S. EPA		Site Location: New Madrid Generating Facility Marston, Missouri	Project No. 01.0170142.20
Photo No. 15	Date: 10/6/10

Direction Photo Taken: Northwest			
Description: Downstream slope of SP2.

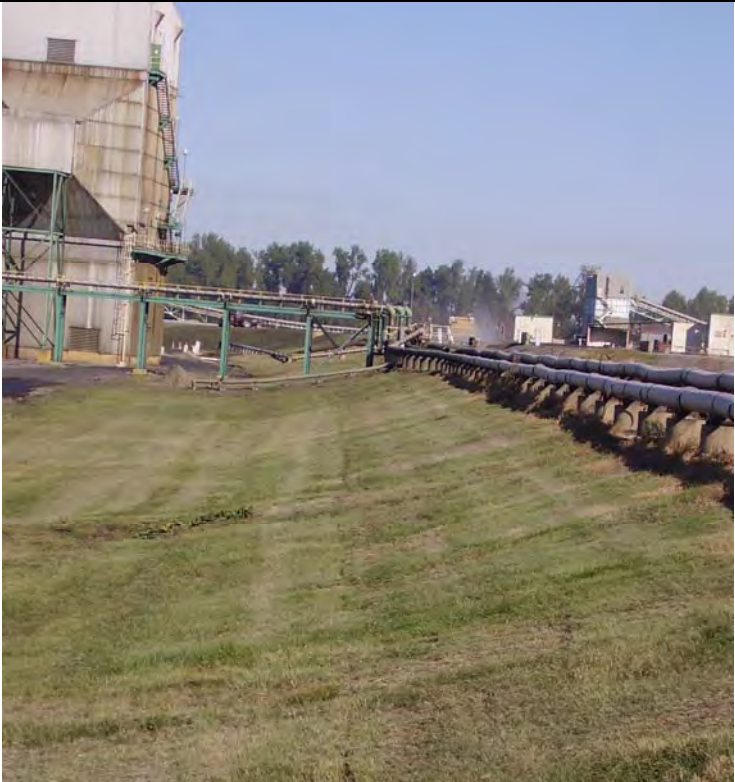
Client Name: U.S. EPA		Site Location: New Madrid Generating Facility Marston, Missouri	Project No. 01.0170142.20
Photo No. 17	Date: 10/6/10

Direction Photo Taken: Northeast			
Description: Downstream slope of the SP2.

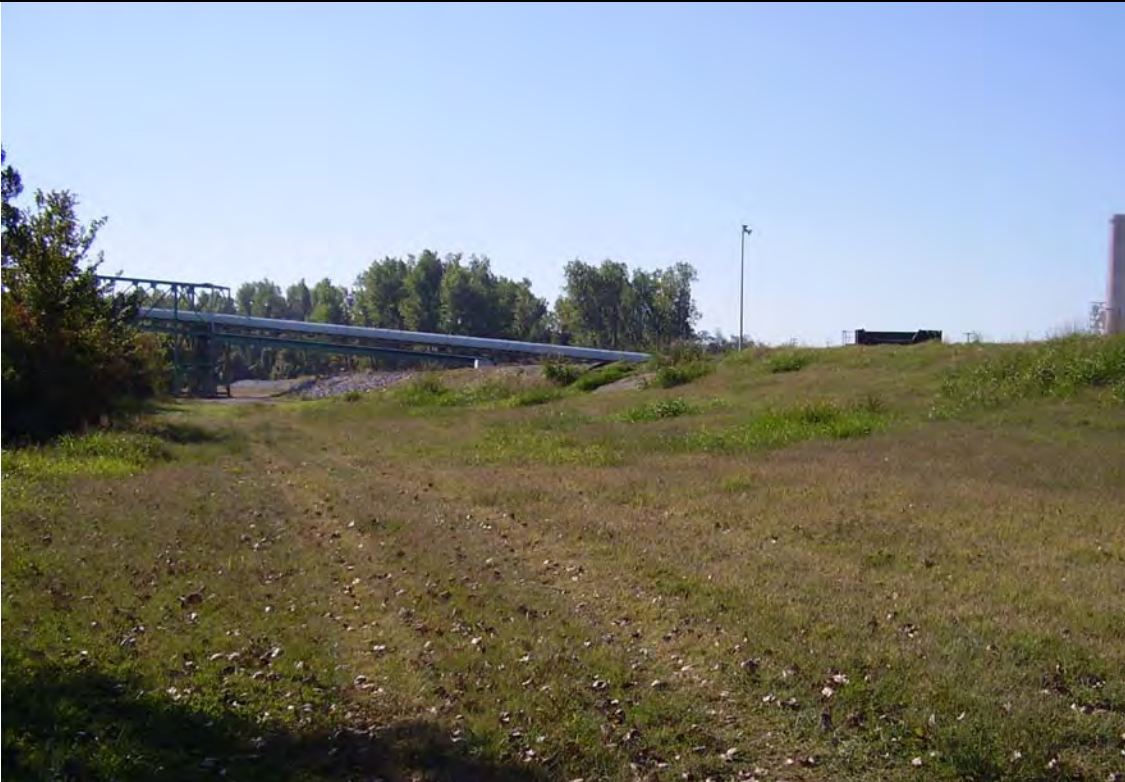
Client Name: U.S. EPA		Site Location: New Madrid Generating Facility Marston, Missouri	Project No. 01.0170142.20
Photo No. 23	Date: 10/6/10

Direction Photo Taken: Southeast			
Description: Downstream slope of the SP2.

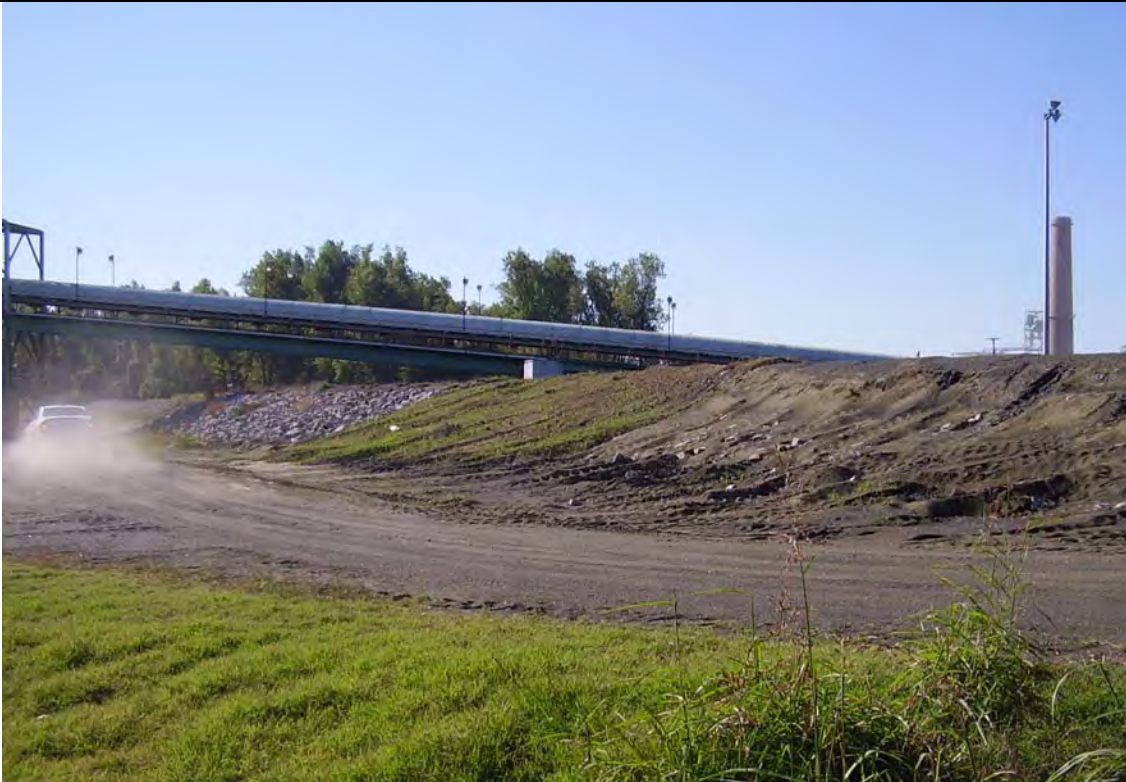
Client Name: U.S. EPA		Site Location: New Madrid Generating Facility Marston, Missouri	Project No. 01.0170142.20
Photo No. 25	Date: 10/6/10

Direction Photo Taken: Southeast			
Description: Erosion of the downstream slope of the SP2.

1. Repair sloughed soil on the western embankment of the AP1 Impoundment.
2. Repair areas of erosion on the AP1 Impoundment, SP1 Impoundment, AP2 Impoundment, and SP2 Impoundment.
3. Repair rutting present on the SP2 Impoundment crest access road.

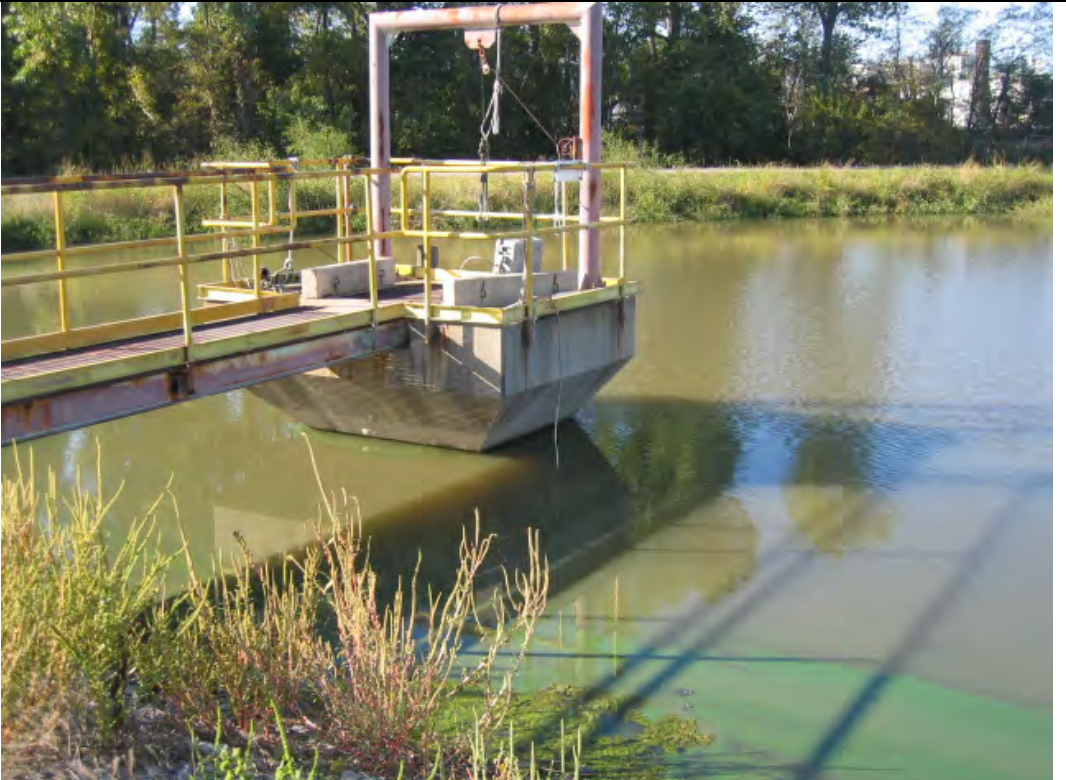
Client Name: U.S. EPA		Site Location: New Madrid Generating Facility Marston, Missouri	Project No. 01.0170142.20
Photo No. 27	Date: 10/6/10

Direction Photo Taken: Southwest			
Description: Decant structure in the SP2.

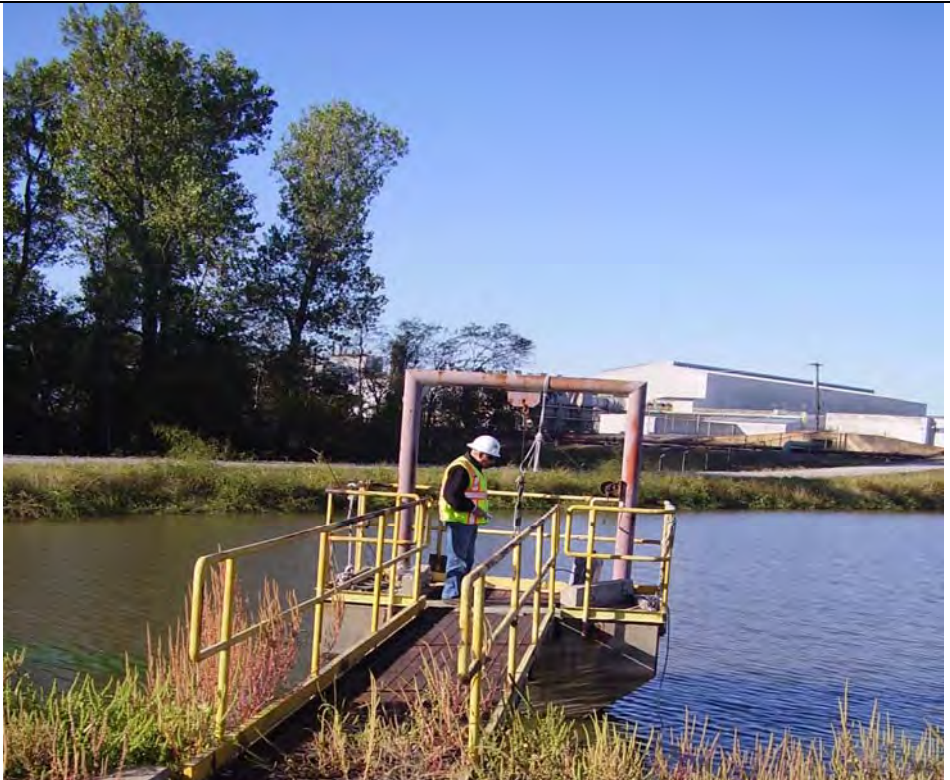
Photo No. 28	Date: 10/6/10

Direction Photo Taken: Southwest		
Description: Decant structure in SP2.

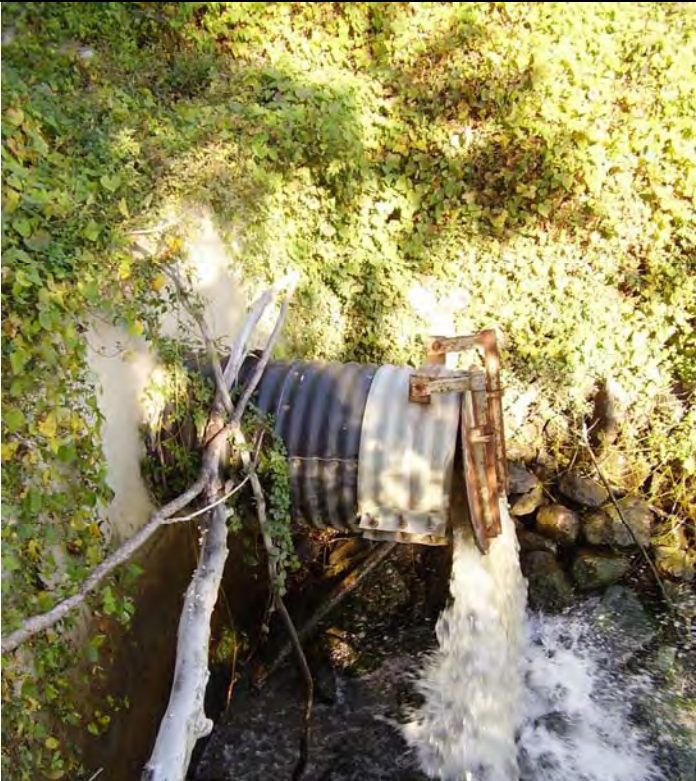
Client Name: U.S. EPA		Site Location: New Madrid Generating Facility Marston, Missouri	Project No. 01.0170142.20
Photo No. 29	Date: 10/6/10

Direction Photo Taken: Northwest			
Description: Discharge pipe from the SP2 decant structure.

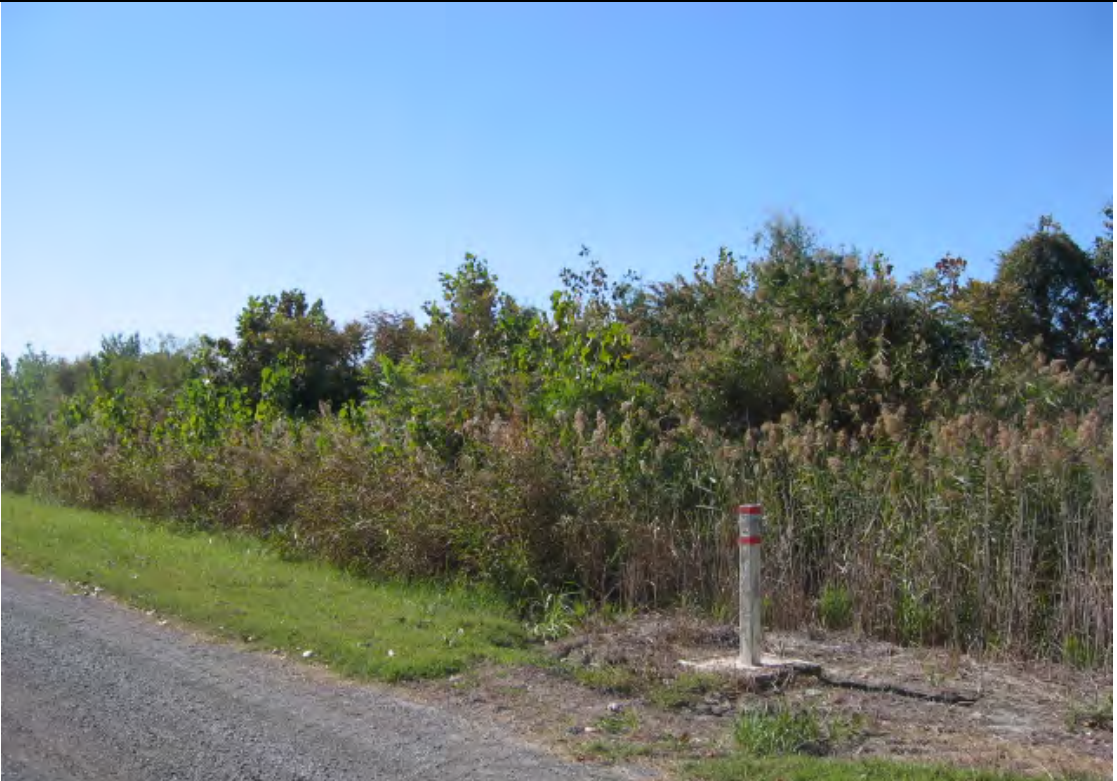
Client Name: U.S. EPA		Site Location: New Madrid Generating Facility Marston, Missouri	Project No. 01.0170142.20
Photo No. 31	Date: 10/6/10

Direction Photo Taken: Southwest			
Description: Upstream area of the Slag Pond 1 Impoundment (SP1).

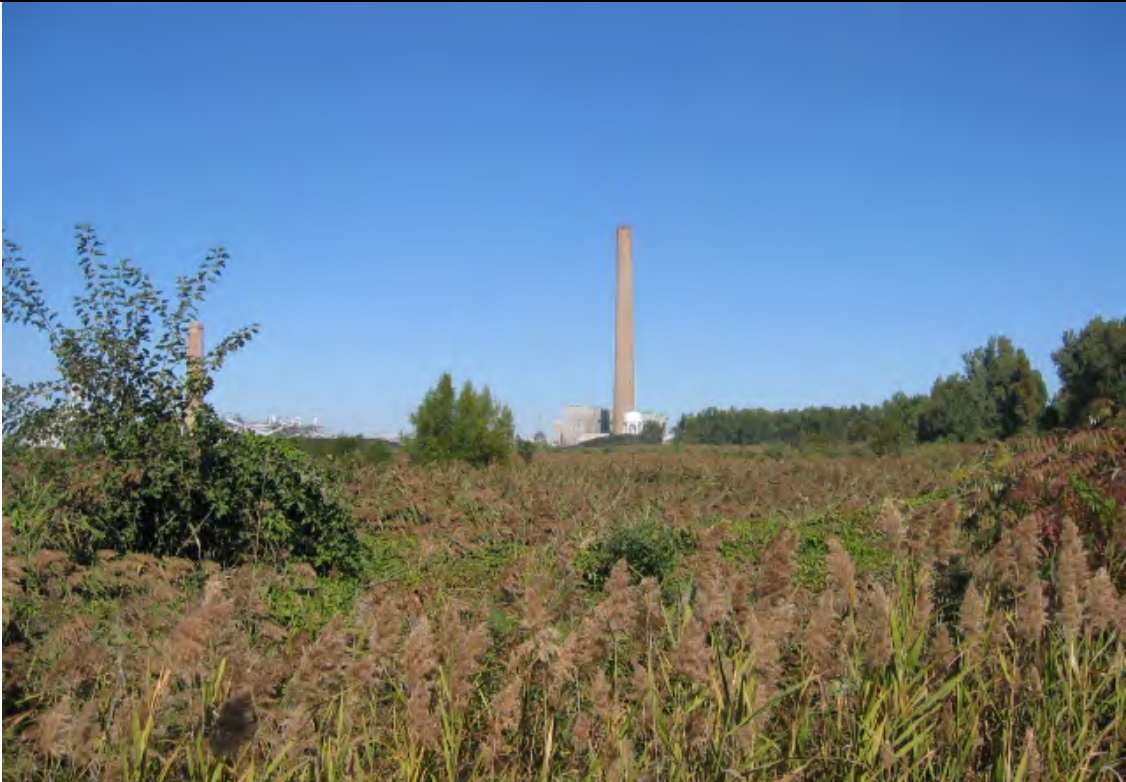
Client Name: U.S. EPA		Site Location: New Madrid Generating Facility Marston, Missouri	Project No. 01.0170142.20
Photo No. 33	Date: 10/6/10

Direction Photo Taken: Northwest			
Description: Long grass and trees present on the upstream areas of SP1.

1. Increased mowing of the grasses on the embankments currently vegetated with tall grasses. The COE recommends vegetation be kept to less than 12 inches in height on embankments to facilitate inspections and reduce the risk of burrowing animals¹.
2. Routine measurements of the groundwater levels in the monitoring wells to evaluate changes in groundwater and seepage conditions.
3. Repair the erosion and grade the gravel access road on the southern embankment of the AP2 Impoundment to allow proper drainage.
4. Clear deep rooted vegetation from embankments, top of impoundments, and within 50 feet of the embankment toes as recommended by the COE.²
5. Topsoil and seed areas of poor vegetation in the AP1 Impoundment, AP2 Impoundment and SP2 Impoundment.
6. Provide protective cover over the Hyperflex© liner in the AP2 Impoundment.

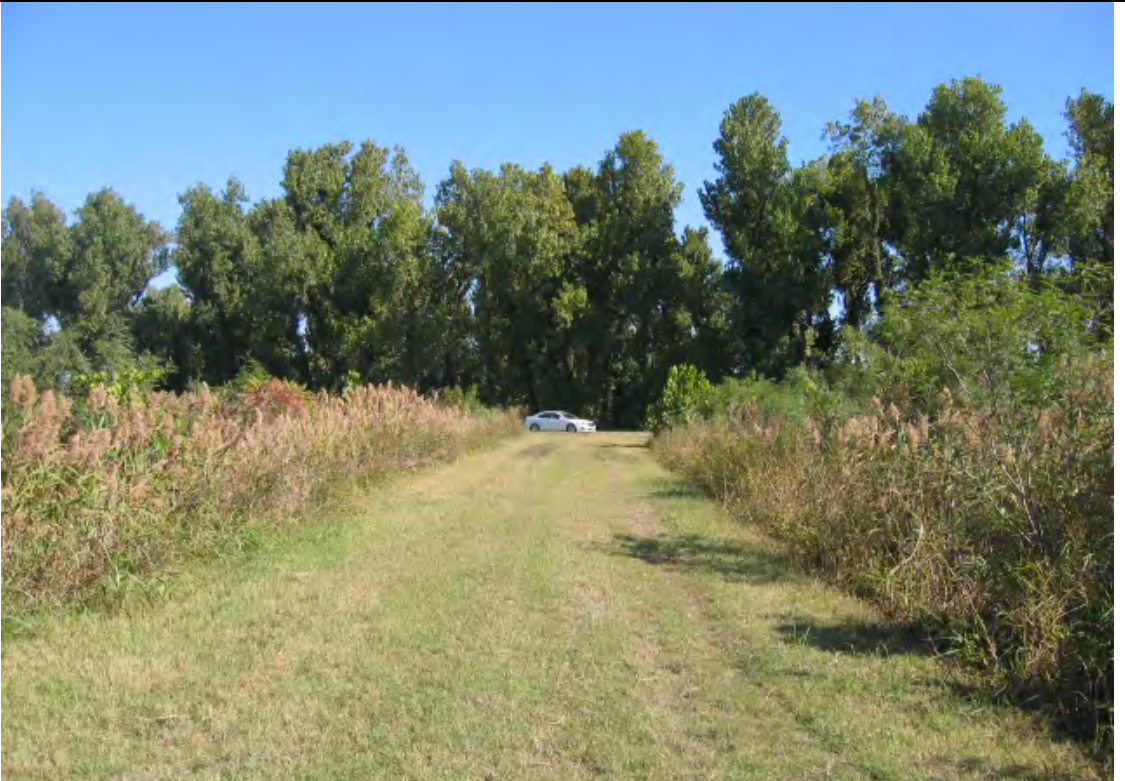
Client Name: U.S. EPA		Site Location: New Madrid Generating Facility Marston, Missouri	Project No. 01.0170142.20
Photo No. 35	Date: 10/6/10

Direction Photo Taken: Northeast			
Description: Crest of the SP1.

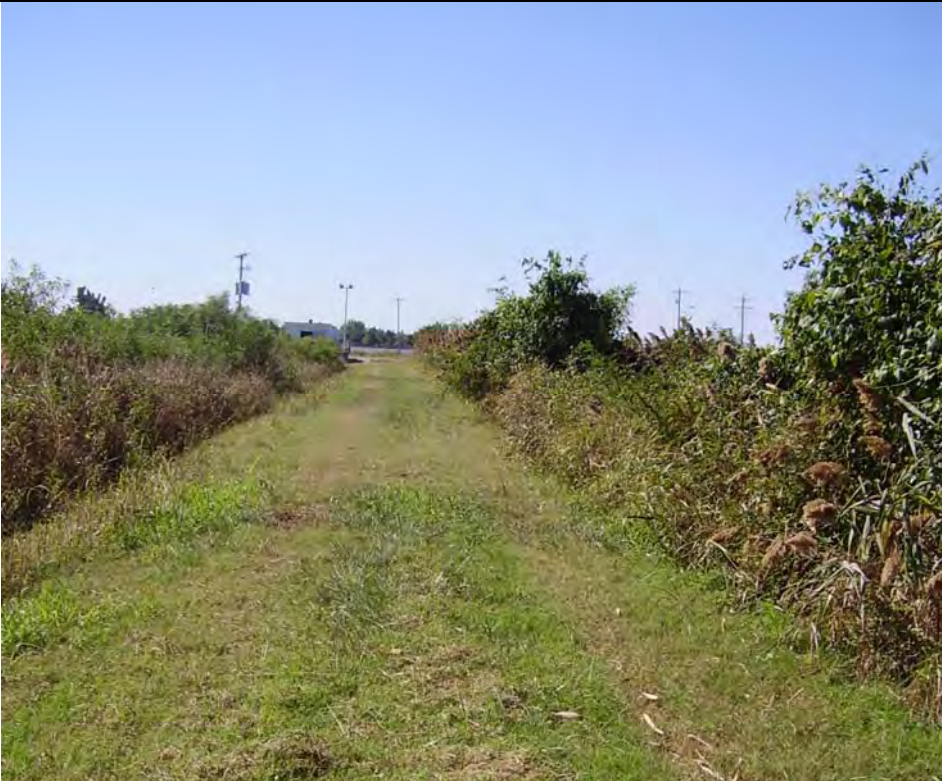
Client Name: U.S. EPA		Site Location: New Madrid Generating Facility Marston, Missouri	Project No. 01.0170142.20
Photo No. 37	Date: 10/6/10

Direction Photo Taken: Southwest			
Description: Crest of the SP1.

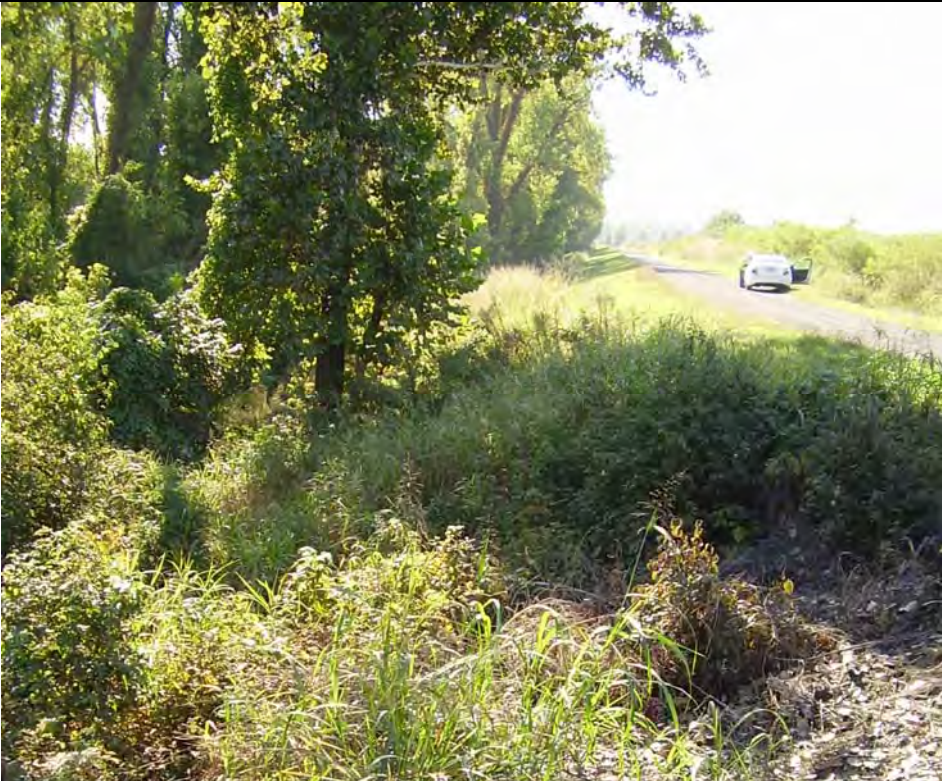
Client Name: U.S. EPA		Site Location: New Madrid Generating Facility Marston, Missouri	Project No. 01.0170142.20
Photo No. 39	Date: 10/6/10

Direction Photo Taken: Southeast			
Description: Erosion and trees on downstream slope of the SP1.

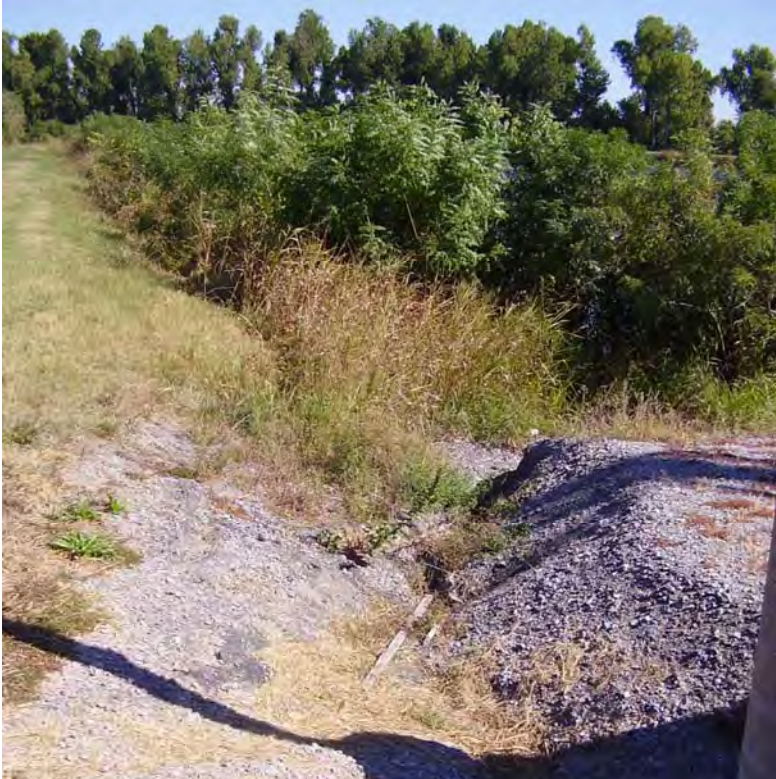
Client Name: U.S. EPA		Site Location: New Madrid Generating Facility Marston, Missouri	Project No. 01.0170142.20
Photo No. 41	Date: 10/6/10

Direction Photo Taken: Northeast			
Description: Eroded ditch on downstream slope of SP1.

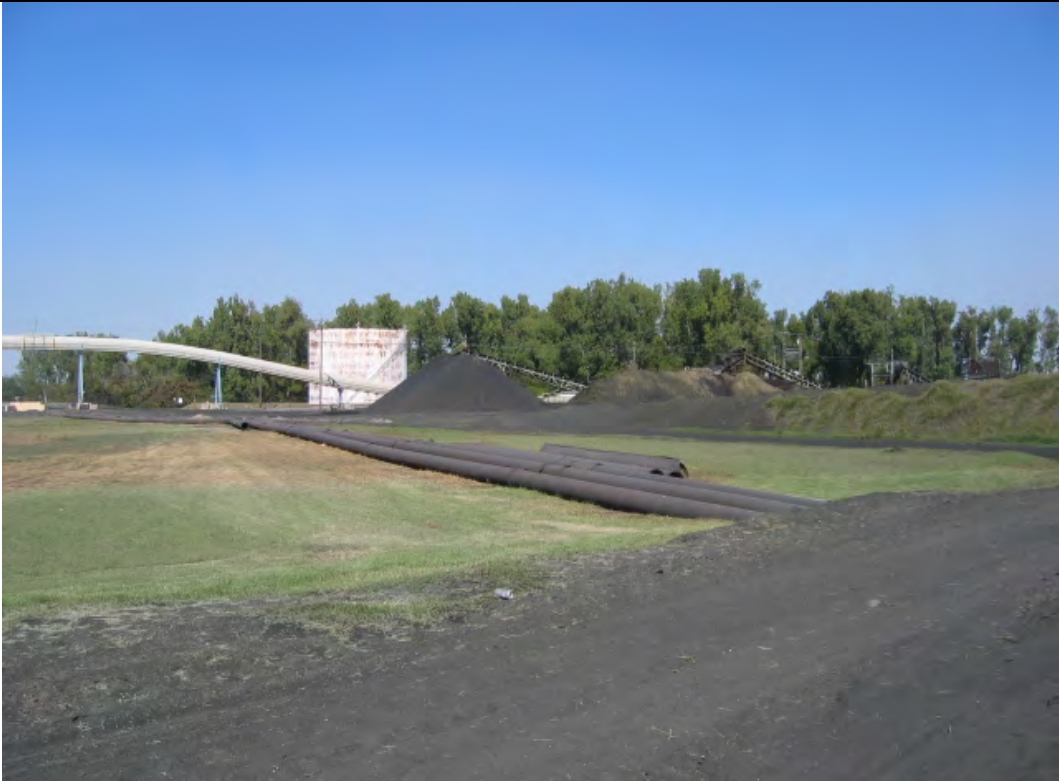
Client Name: U.S. EPA		Site Location: New Madrid Generating Facility Marston, Missouri	Project No. 01.0170142.20
Photo No. 43	Date: 10/6/10

Direction Photo Taken: Northeast			
Description: Upstream area of the Ash Pond 1 impoundment (AP1).

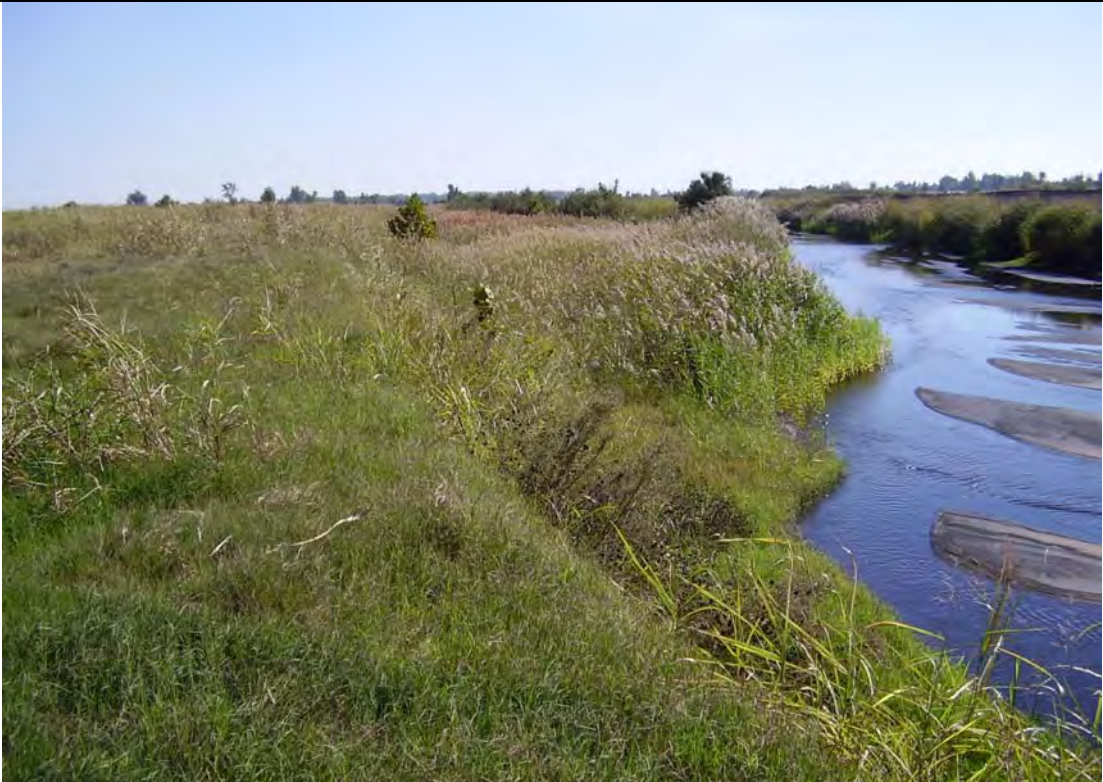
Client Name: U.S. EPA		Site Location: New Madrid Generating Facility Marston, Missouri	Project No. 01.0170142.20
Photo No. 45	Date: 10/6/10

Direction Photo Taken: South			
Description: Area within AP1 showing water drainage channel.

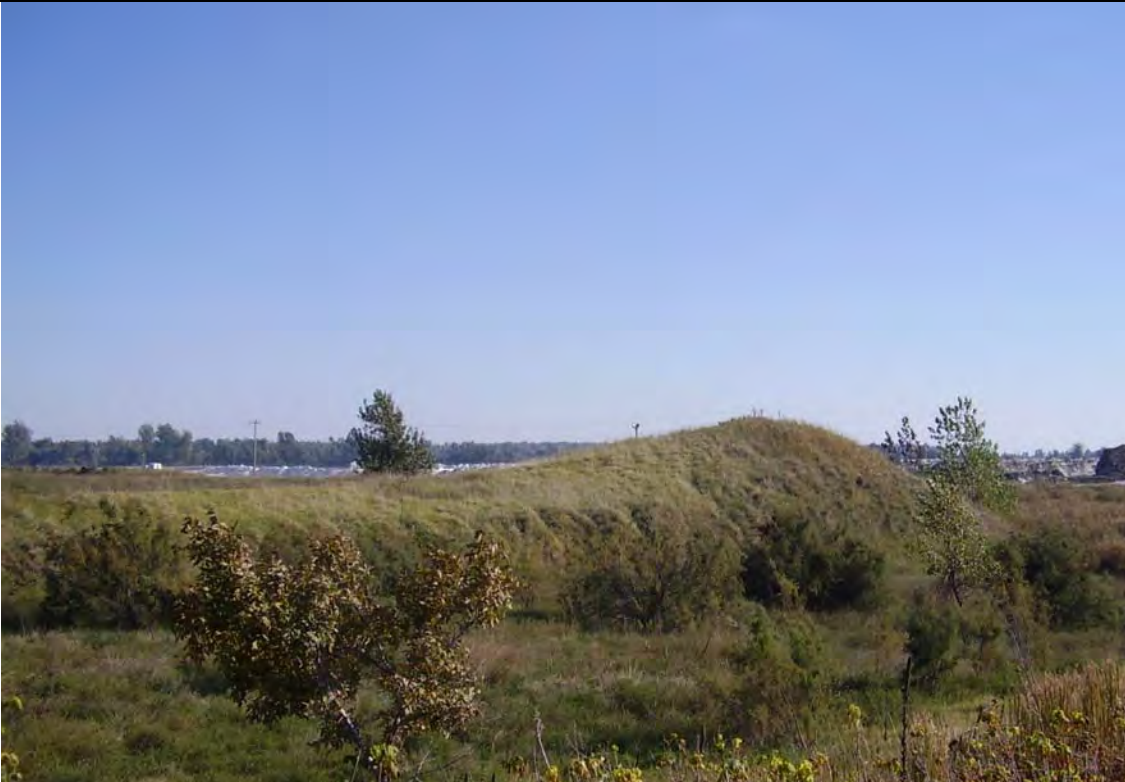
Client Name: U.S. EPA		Site Location: New Madrid Generating Facility Marston, Missouri	Project No. 01.0170142.20
Photo No. 47	Date: 10/6/10

Direction Photo Taken: Southeast			
Description: Mounded ash with vegetation with the AP1.

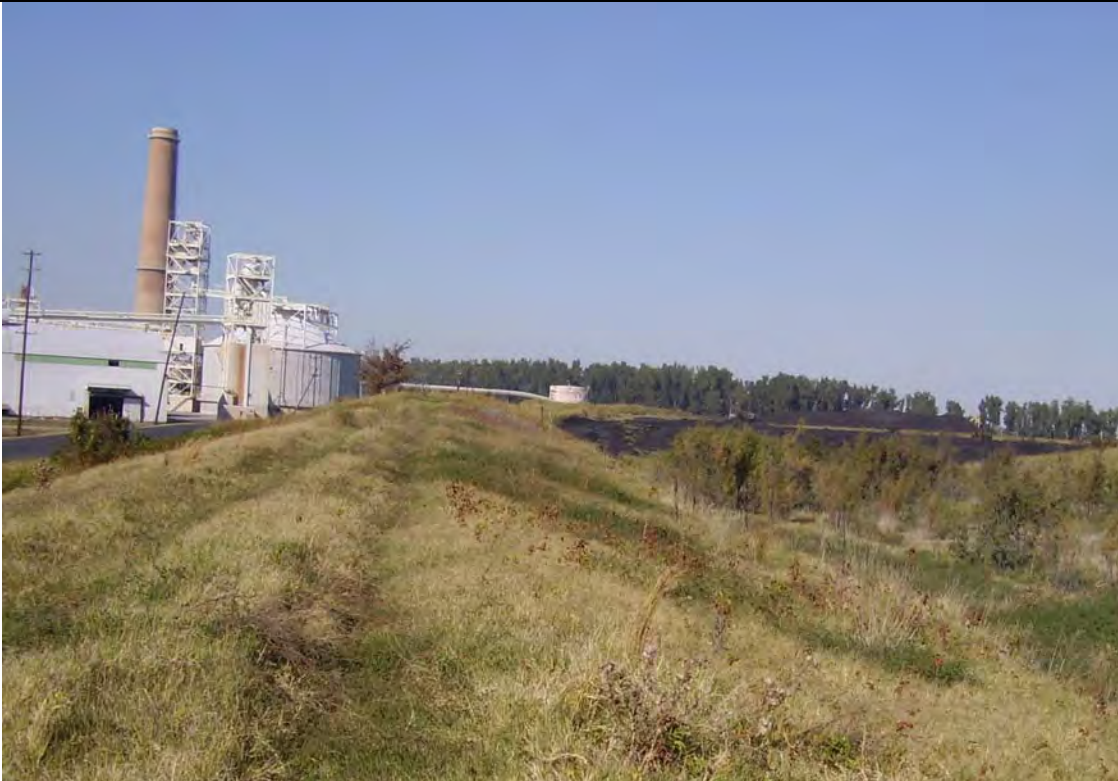
Client Name: U.S. EPA		Site Location: New Madrid Generating Facility Marston, Missouri	Project No. 01.0170142.20
Photo No. 49	Date: 10/6/10

Direction Photo Taken: Northeast			
Description: Mounded ash with vegetation with the AP1

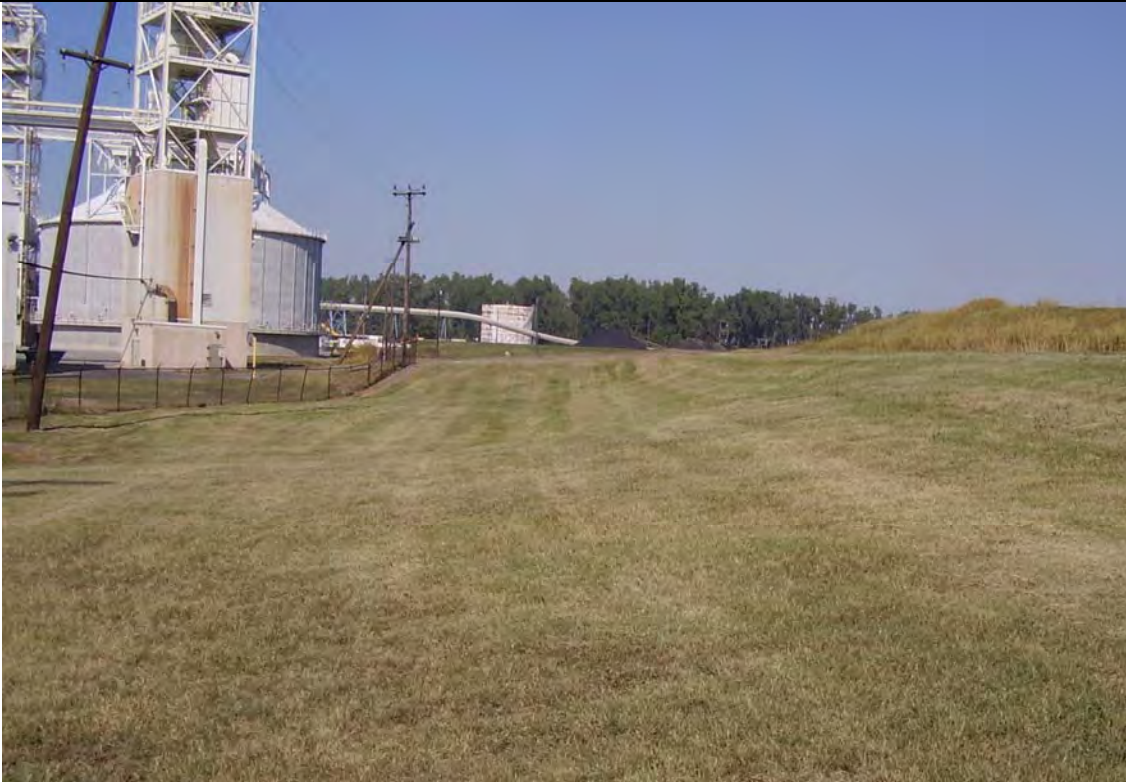
Client Name: U.S. EPA		Site Location: New Madrid Generating Facility Marston, Missouri	Project No. 01.0170142.20
Photo No. 53	Date: 10/6/10

Direction Photo Taken: Northeast			
Description: Downstream slope of the AP1.

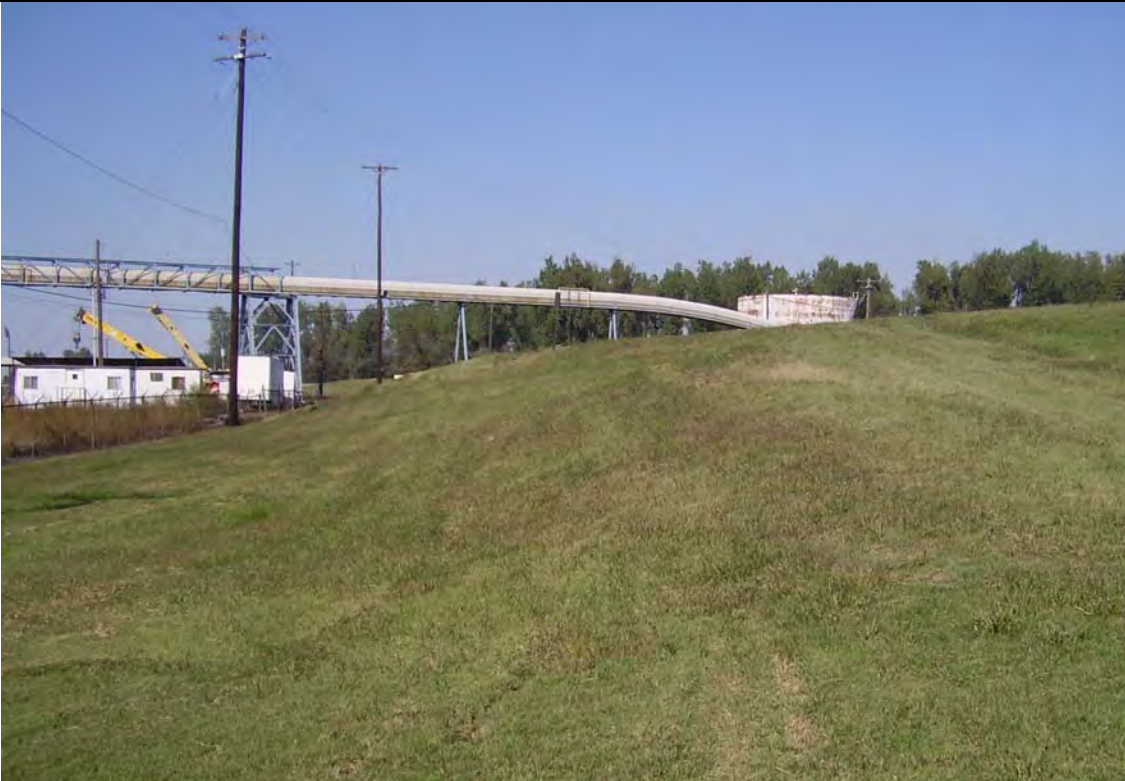
Client Name: U.S. EPA		Site Location: New Madrid Generating Facility Marston, Missouri	Project No. 01.0170142.20
Photo No. 55	Date: 10/6/10

Direction Photo Taken: North			
Description: Downstream slope of the AP1.
